PEPPERELL PAPER CO. DAM

MA 00373

PHASE I INSPECTION REPORT  
NATIONAL DAM INSPECTION PROGRAM

AUGUST 1978

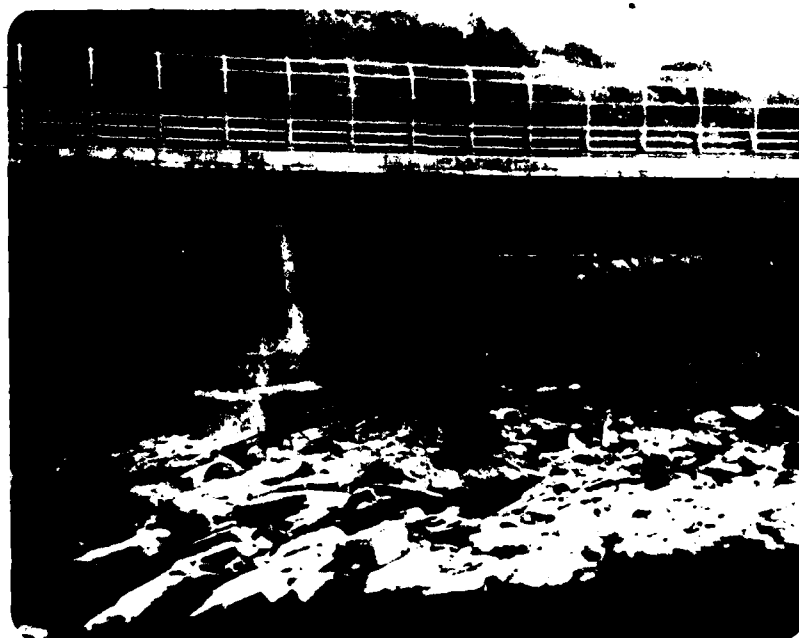
b. Dam. The concrete overflow section had many areas on the downstream face which showed major spalling and abrasion. At one time the downstream face was repaired by spraying with gunite. Many areas of the gunite have since peeled off with the reinforcement bars exposed. There is some undercutting of the toe. The abutments are integral with the surrounding natural grade and highway. On the event of overtopping, water would flow between the downstream side of the abutments and the upstream side of the highway bridge.

Based on visual observations during the site examination, the general condition of the project is fair. Although concrete surfaces, especially at the downstream face of the dam, have experienced considerable spalling and deterioration, these present conditions should not have any serious effect on the performance of the dam. However, this condition should be corrected before further deterioration occurs, which could create hazardous conditions in the future.

Downstream Face of Dam taken  
from Downstream Channel

The owner of the dam should develop and implement procedures which would include periodic inspection of the dam and the initiation of repairs, as required. Presently required maintenance includes repair of all spalled concrete and the application of dental concrete in the undercut areas at the toe of the dam.
